## TEST REPORT NO. 18/10-A007-B3

Performance testing accordance with EN 1191:2012 “Windows and doors – Resistance to repeated opening and closing – Test method”. The test (vertical motion) was performed for 10,000 cycles

<b>Order No.</b>	18/10-A007
<b>Applicant</b>	Eliz Cam Sistemleri. Sarıçam Sokak No:62 Siteler - Ankara Türkiye
<b>Product type</b>	Vertical-Travel guillotine window, with one fixed and two sliding panels parts vertically controlled by electric drive, Aluminum, single glazing
<b>Product name</b>	<b>Giotech 300</b>
<b>Conducted tests</b>	- Resistance to repeated opening and closing
<b>Responsible test person</b>	Dipl.-Ing. (FH) Rüdiger Müller

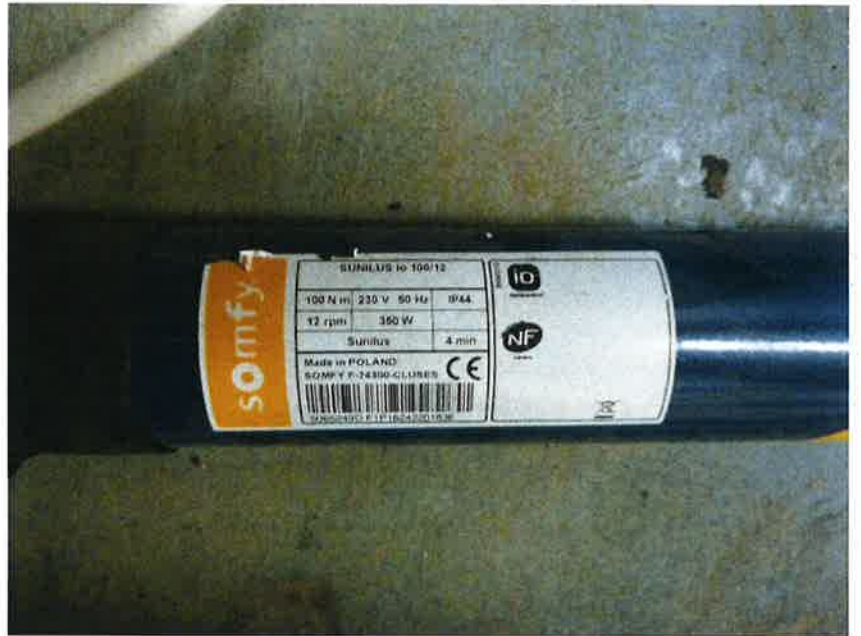
Image 3:

Test sample No.18/10-A007-P3,  
electric drive.

In order to prevent overheating in the electric motor, the sample is tested with the back cover of upper box open.

In order to prevent the electric motor from going into protection mode due to overheating, the test was performed for 12 minutes rest after each 1 turn.

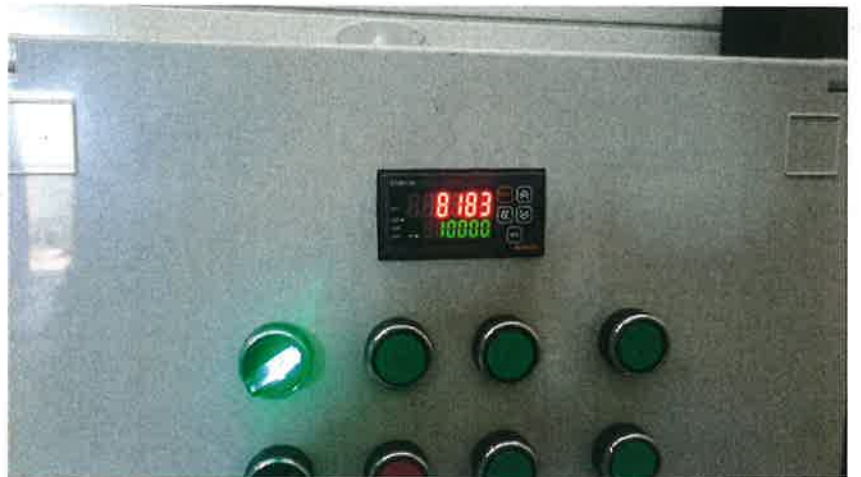
Image 4:

Test sample No.18/10-A007-P3,  
cycle counter.

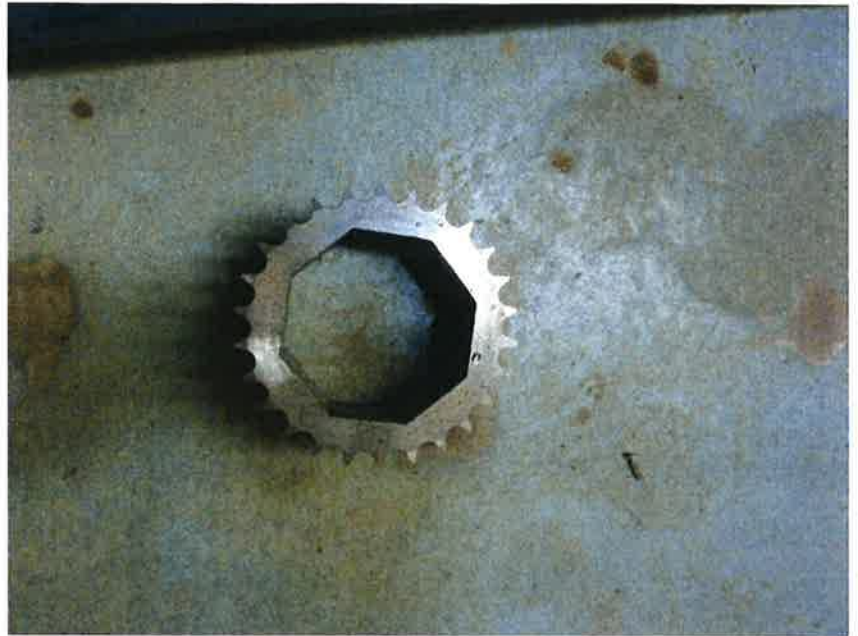
Image 5:

Test sample No.18/10-A007-P3,  
operating mechanism part.

Profile cross section:	Frame approx. 108 mm x 90 mm, Casement approx. 42 mm x 35 mm,
Sealing:	Brush and rubber sealing
Operating mechanism	Steel sprocket and chain
Closing/Locking system:	Somfy IO 120nm/12rpm
Glazing/infill:	8mm tempered glass.

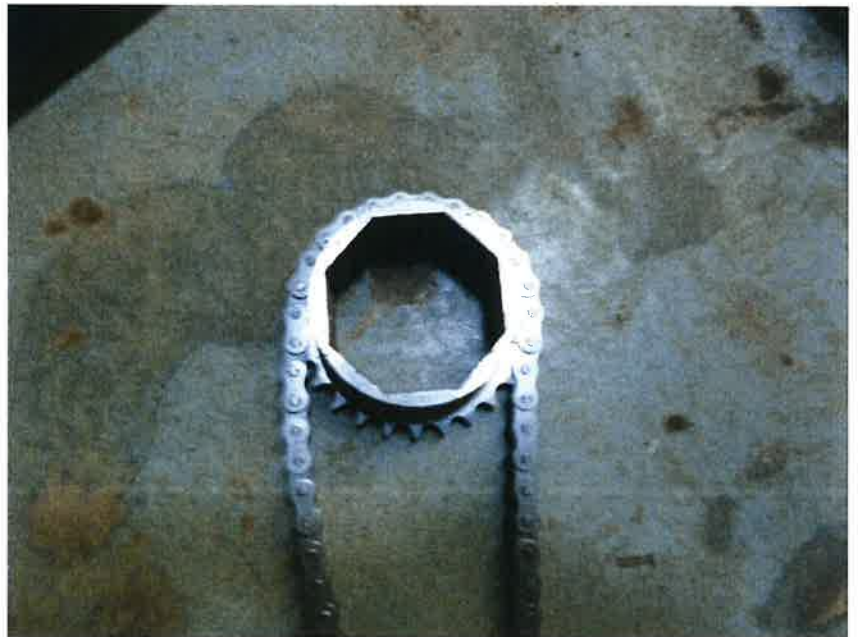
Image 6:

Test sample No.18/10-A007-P3,  
operating mechanism part with  
chain.

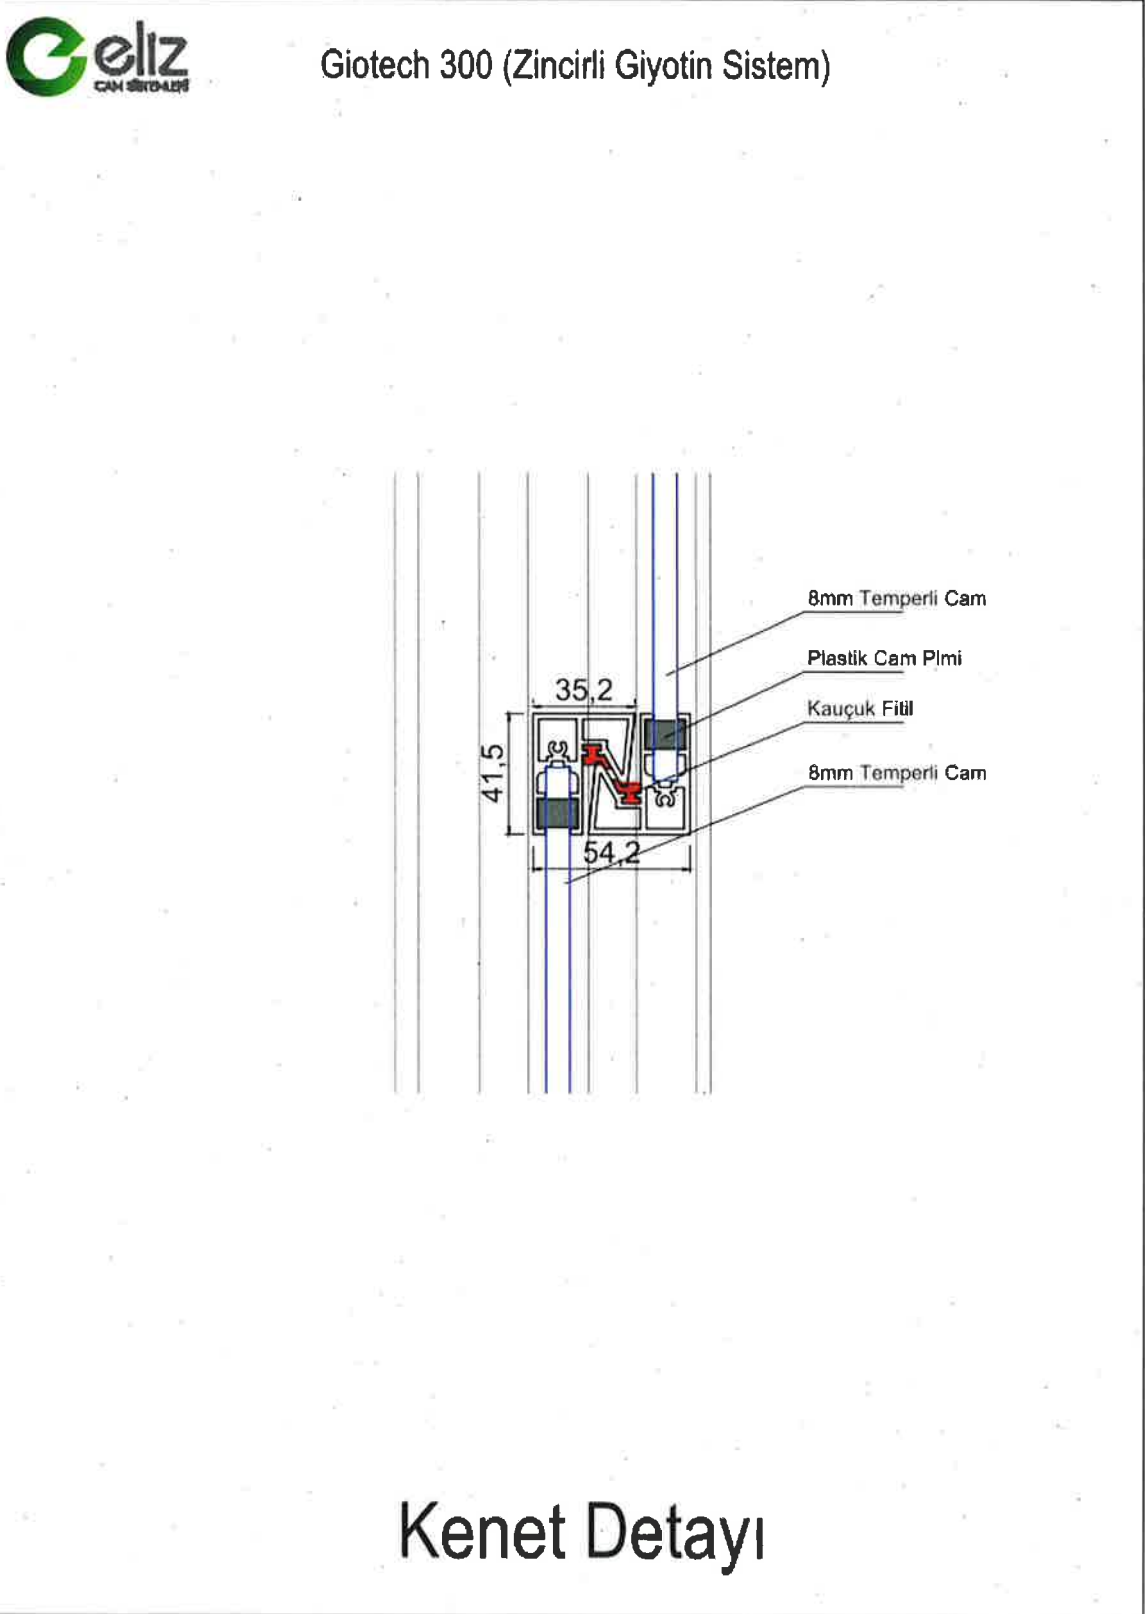
## Giotech 300 (Zincirli Giyotin Sistem)

- “Front view ” (attachment 4)
- “Section view (Motor kutusu detayı)” (attachment 5)
- “Section view (Kenet detayı)” (attachment 6)
- “Section view (Dikey ray detayı)” (attachment 7)
